82545EM Gigabit Ethernet Controller Specification Update

June 6, 2006

The *82545EM* Gigabit Ethernet Controller may contain design defects or errors known as errata that may cause the product to deviate from published specifications. Current characterized errata are documented in this Specification Update.

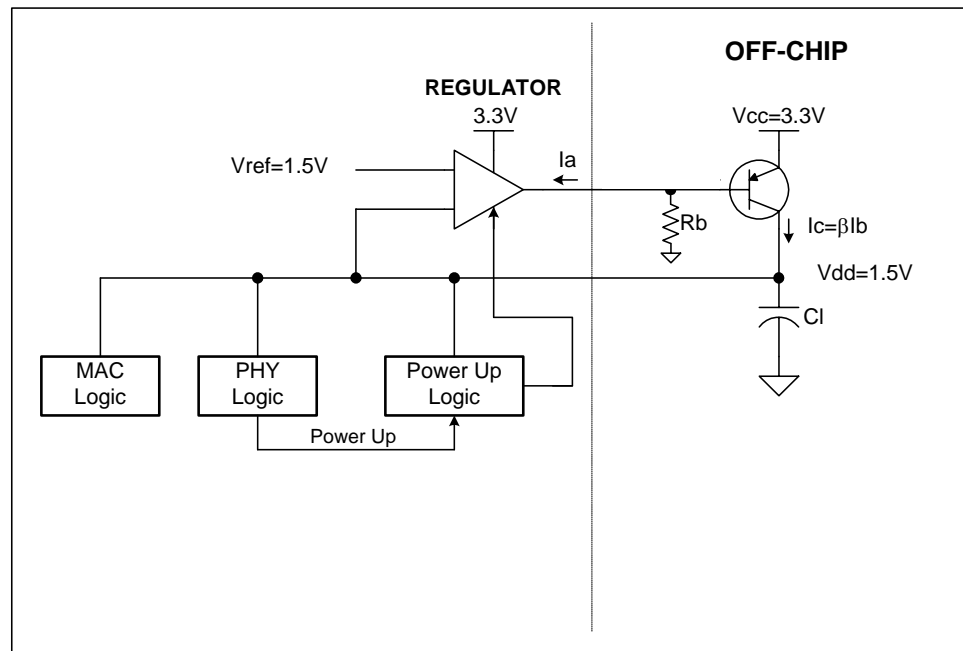
- Implication:** When drive is absent on the CTRL_15 output, only leakage current from the CTRL_15 output will be present. Depending on the amount of leakage current and the gain (Beta) of the external PNP transistor, there may be insufficient collector current ($I_C = I_B * \text{Beta}$) to adequately supply the 1.5V rail, and the 1.5V regulator circuit may not turn on. The 1.5V rail requires a minimum collector current of 5 mA to be generated and a 1.5V rail voltage of at least 600 mV to ensure that the digital portion of the circuit turns on correctly.

When the 1.5V regulator control output fails, the 2.5V regulator control output(s) may also fail, driving the 2.5V supply toward either 0V or the 3.3V rail. The absence of one or both of the 1.5V and/or 2.5V supplies prevents the Ethernet controller from operating correctly.

- Workaround:** The regulator control output is Ball A18 on the 82545EM controller. Intel's original reference designs showed two external resistors, R1 and R2, in this circuit. The workaround completely removes R2 and replaces it with another resistor, Rb, connected between the CTRL_15 output and ground.

Systems that generate 1.5V without using the Ethernet controller's onboard regulator control (for example, at a central power supply) do not need a workaround. No changes are required for the 2.5V regulator circuit.
