TECHNICAL BULLETIN

No. 427-02-04

MODEL AFFECTED: 427

SUBJECT: INTRODUCTION OF NEW HARDENED WEAR SLEEVE P/N 427-044-123-101.

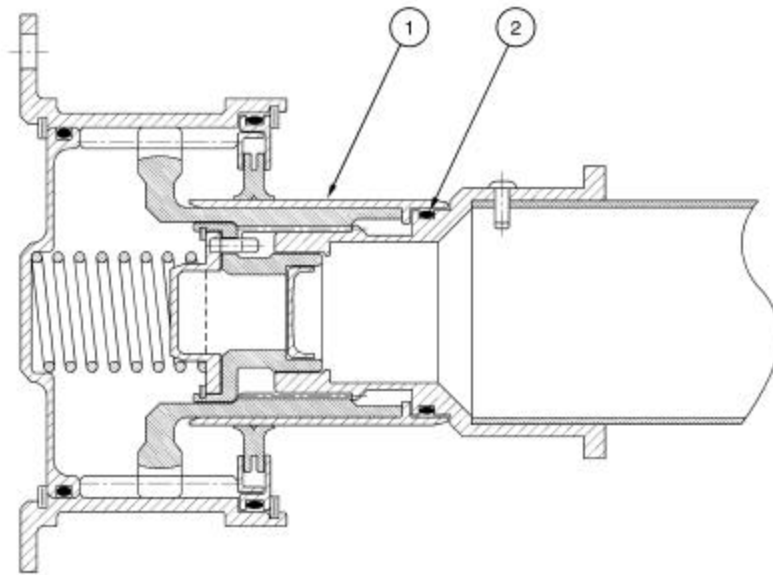
FIGURE 1. FORWARD TAIL ROTOR DRIVESHAFT

Field reports indicate that the wear sleeves P/N 427-044-117-101 installed on forward tail rotor driveshaft assembly P/N 427-044-100-103 tends to exhibit a premature wear groove.

1. Remove forward driveshaft P/N 427-044-100-103 from aircraft per BHT-427-MM Chapter 65.
2. Disassemble driveshaft per BHT-427-MM Chapter 65.
3. Remove and discard wear sleeves P/N 427-044-117-101 and packing P/N M83248/1-130. (Refer to figure 1).
4. Reassemble driveshaft per BHT-427-MM Chapter 65 using new wear sleeves P/N 427-044-123-101.
5. Re-identify driveshaft data plate and historical service record from P/N 427-044-100-103 to P/N 427-044-100-103-105FM.
6. Install forward driveshaft P/N 427-044-100-105FM in the aircraft per BHT-427-MM Chapter 65.
7. Annotate records to reflect compliance with this bulletin.
